Petrochemical company uses online information to keep critical machine running

Gulf Petrochemical Industries Company, Bahrain

by **Ron Bosmans**
Principal Engineer
Bently Nevada Corporation

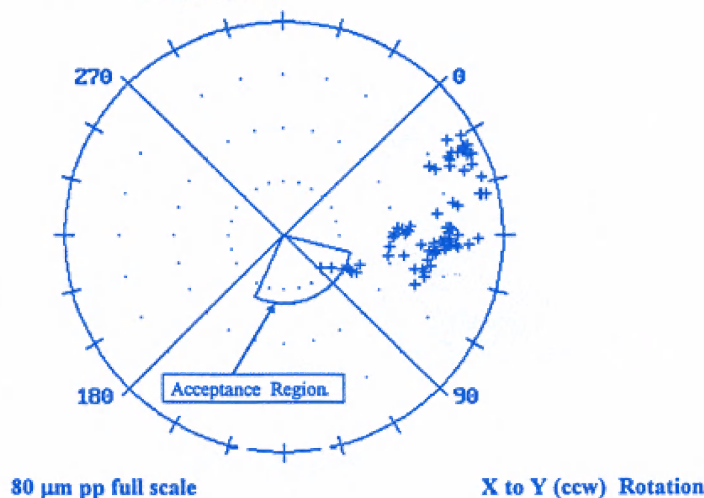
Figure 2
Acceptance Region plot

The TDM2 trend files revealed that the changes in the 1X vectors began to occur during the second two weeks in September 1994. Plant personnel were aware that these changes were occurring over this period and were concerned about continued operation of the machine.►

The Engineer Assist audit, based on vibration data from the TDM2 System, indicated several explanations for this type of behavior. They include changes in the balance state of the rotor and a rotor crack that is propagating. A rotor crack possibility could be confirmed if recent startup or shutdown data were available. However, the only shutdown data available was from a shutdown in October 1993. The data had been acquired with an ADRE® (Advanced Diagnostics for Rotating Equipment) for Windows System; this was old data, but it was still considered useful. The data revealed that the compressor was operating at a speed just above the second balance resonance (critical speed). See Figures 3 and 4. A small increase or decrease in the resonance frequency would explain the observed 1X amplitude and phase change. The equation that governs the frequency of a mechanical resonance is:

Engineer Assist reported that the 1X phase changes were categorized as "leading" phase angle changes. This would indicate that the second balance resonance frequency, which was initially below operating speed, had increased and is now above operating speed. System stiffness for that mode must have increased. Where? How?

Preparations were made to shut down the machine train on January 14, 1995. To safely manage the machine until then, we defined a new Acceptance Region on December 15. If the new Acceptance Region were violated, the machine would be shut down immediately. The rotor's response (Figures 5 and 6) during shutdown indicates that, at the time of the shutdown, the second balance resonance frequency was above running speed. This data confirms the suspected change in system stiffness. Upon removal of the rotor, the seal area was inspected. The substance found on the rotor was identical to that found on the previous rotor. The diametral clearance in the seal had been reduced to 0.01 mm (0.4 mil).

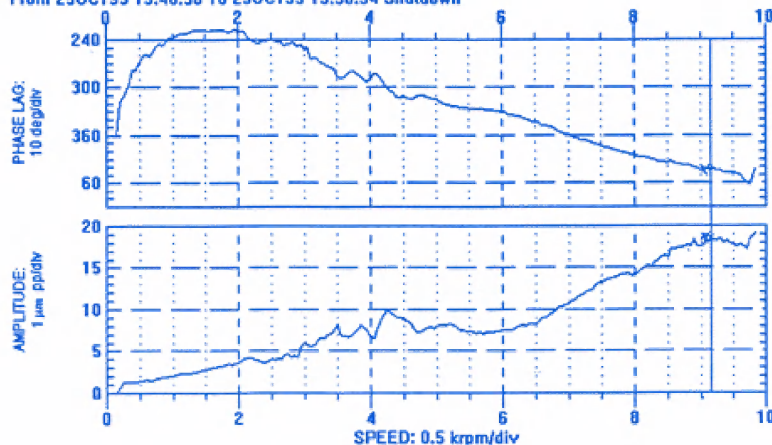
Figure 3
Bode plot of October 1993 shutdown

Note: Compressor operates at 10,400 rpm
Second balance resonance frequency is 9,150 cpm
